This Could Easily Happen in Ontario!

Gerry Mulhern, P.Eng.
Executive Director – OCPA

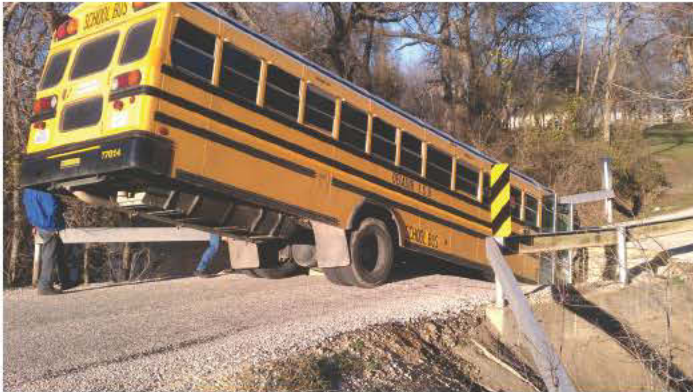
*A school bus in a crater caused by a collapsed corrugated steel pipe
photo credit: Dustin Hood*

A corrugated steel pipe collapsed under the weight of a school bus in Rhome, Texas on Thursday January 26th, leaving the bus stuck with its rear in the air. Only four of the day's 63 passengers were still on board at the time and the driver was able to get those students evacuated with no injuries.

The area had received approximately 150mm of rain in a thirty six hour period preceding the corrugated steel pipe collapse and it is speculated that this rainfall washed away much of the pipe's soil support. The bus driver stopped the bus short of the culvert and then stopped again after her front wheels rolled over the culvert and immediately started to sink.

"The main thing is no one was hurt," White said. "Everything else can be put back as good as it was or better than it was." The commissioner said the narrow, one-lane crossing will be replaced by a 24-foot, two-lane bridge 53 feet in length.

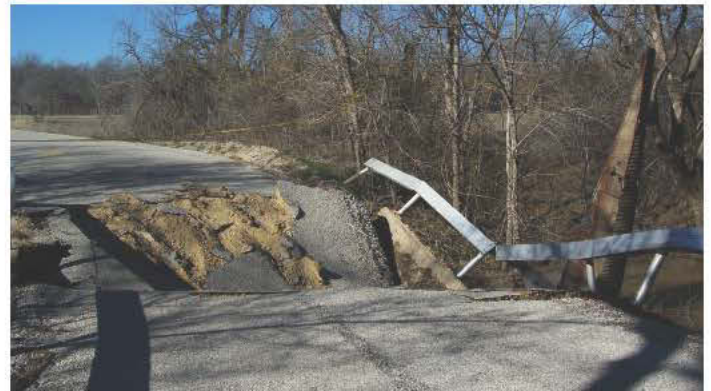
*Crater caused by the corrugated steel pipe failure
A section of the CSP is visible on the right hand side
of the picture projecting vertically
photo credit: John Dutschmann, Technical Resource Manager
Hanson Pipe and Precast*

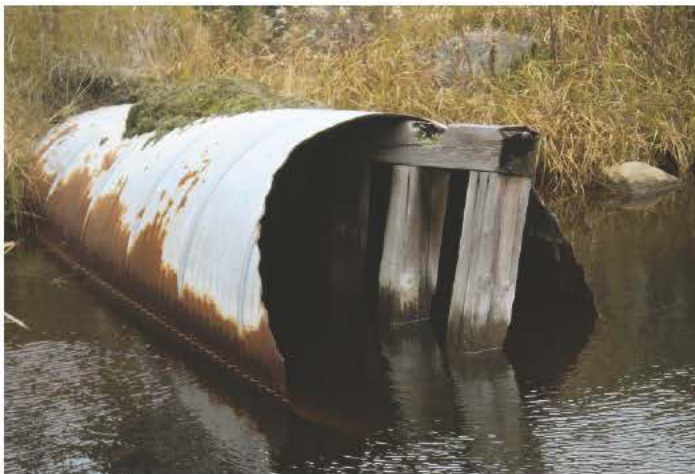
A near catastrophe like this in the United States should encourage us to take a close look at our buried infrastructure across Ontario. In 2009 the Executive Director of the Sudbury Student Services Consortium (SSSC) wrote to her local MPP after a television report of deteriorating and severely

Deteriorated culverts under Trans Canada Highway
